AFOEM Annual Training Meeting 2026

Worksite Visit Program

New Preston Tram Depot, Preston
Pre-Visit Scenario | Registrar Copy

Site	Yarra Trams Depot – 18 Miller Street, Preston, VIC
Required PPE	Safety shoes; high-visibility vest

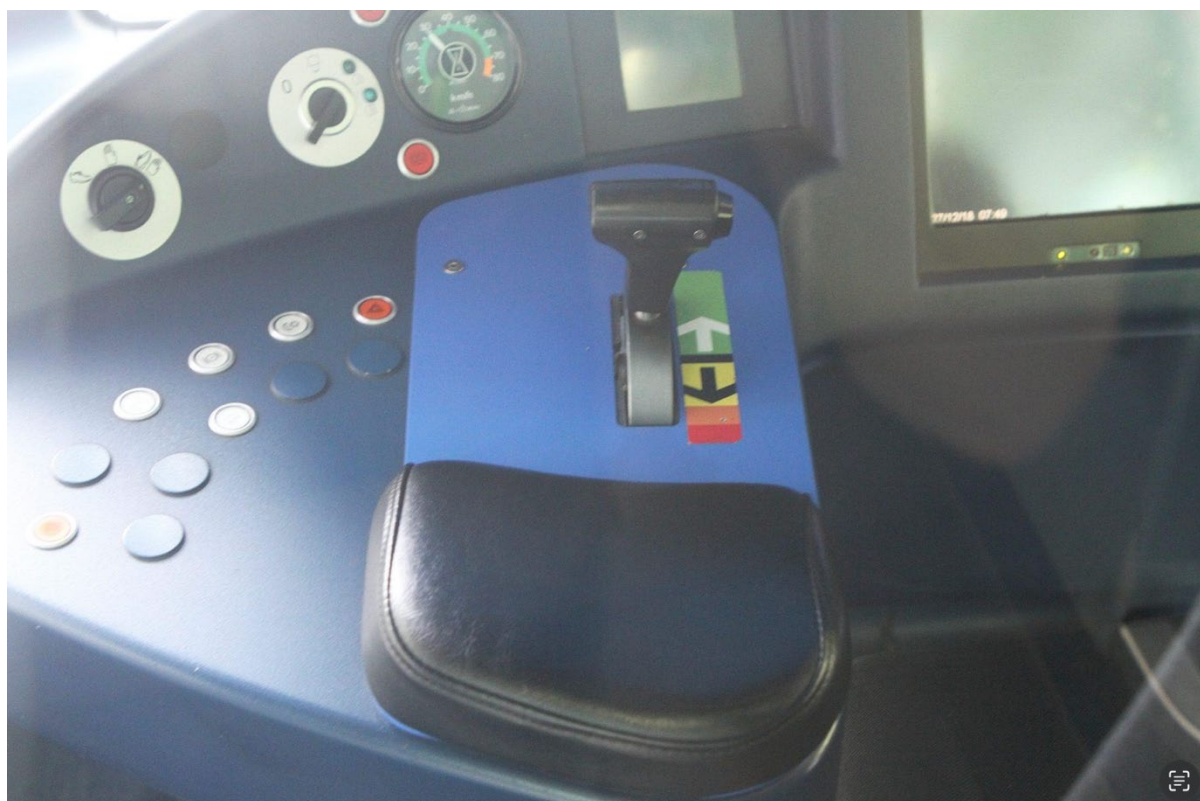
The worker attributed his condition to the use of the tram ‘Master Controller’ which required sustained unsupported forearm posture in addition to repeated manipulation and sustained downward pressure – see photo below.
